Manhole Inspection Summary

Manhole # S29EE1024MH

Location Address: **3756 TUDOR ARMS AVE**

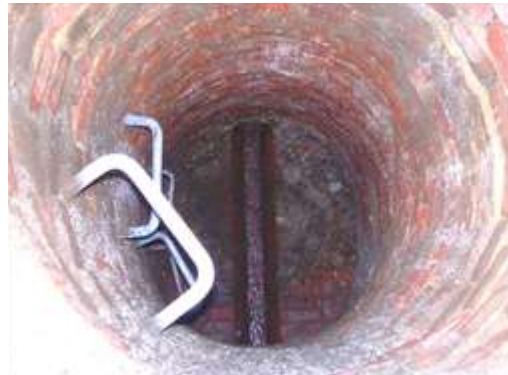
Top View

Bench debris.

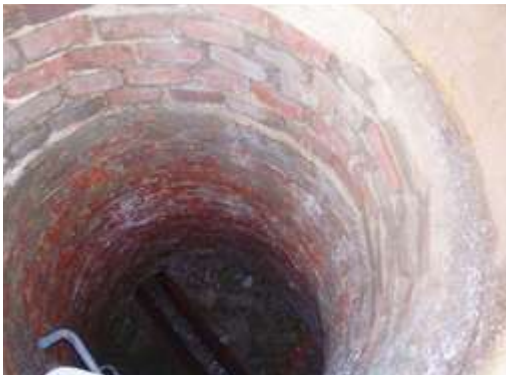
Defect

Frame Offset: **1** (in.)

☒ **Leaks**

Infiltration: ☐ None ☒ **Joint** ☐ Cracks ☐ Mortar ☐ Roots ☒ **Wall**

Infiltration: ☐ None ☐ Joint ☐ Cracks ☐ Mortar ☐ Roots ☒ **Wall**

Frame leaks. Frame offset. Corbel and Barrel infiltration.

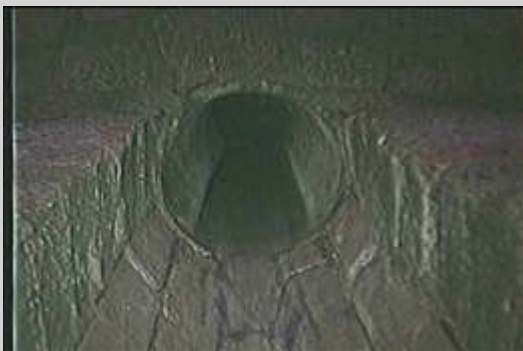
8 in. Circular Gravity Sewer Pipe In @ 6 O'Clock

Infiltration: **Evidence** Pipe Seal Cond: **Cracked**
